### The Project

The project is planned to be an open pit copper and gold mine with associated infrastructure, including:

### **Environmental and Social Impact** Assessment Process

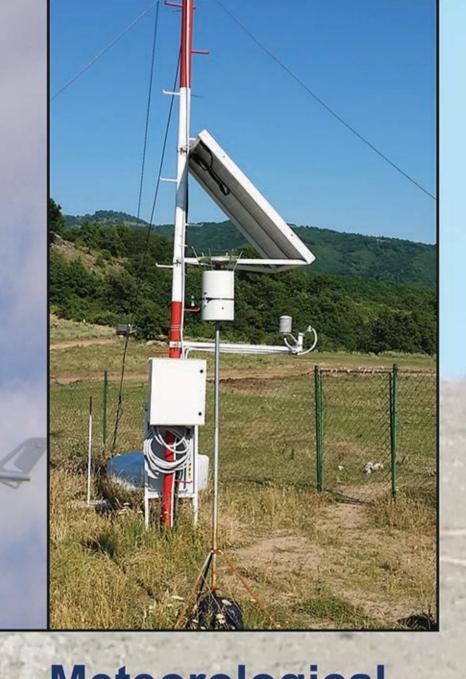
Meteorological monitoring station

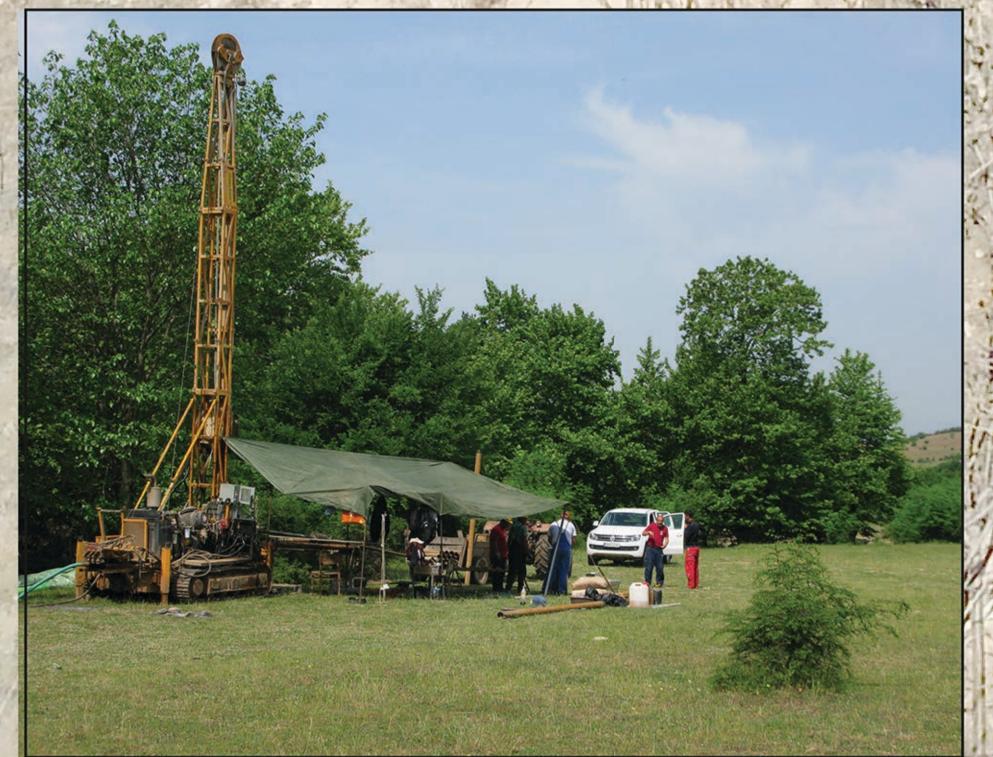
Installing piezometers for measuring groundwater levels

Groundwater level data have been collected from a number of sources, including drill holes around the site, village wells, and irrigation boreholes. Flows have been measured from naturally occurring springs.

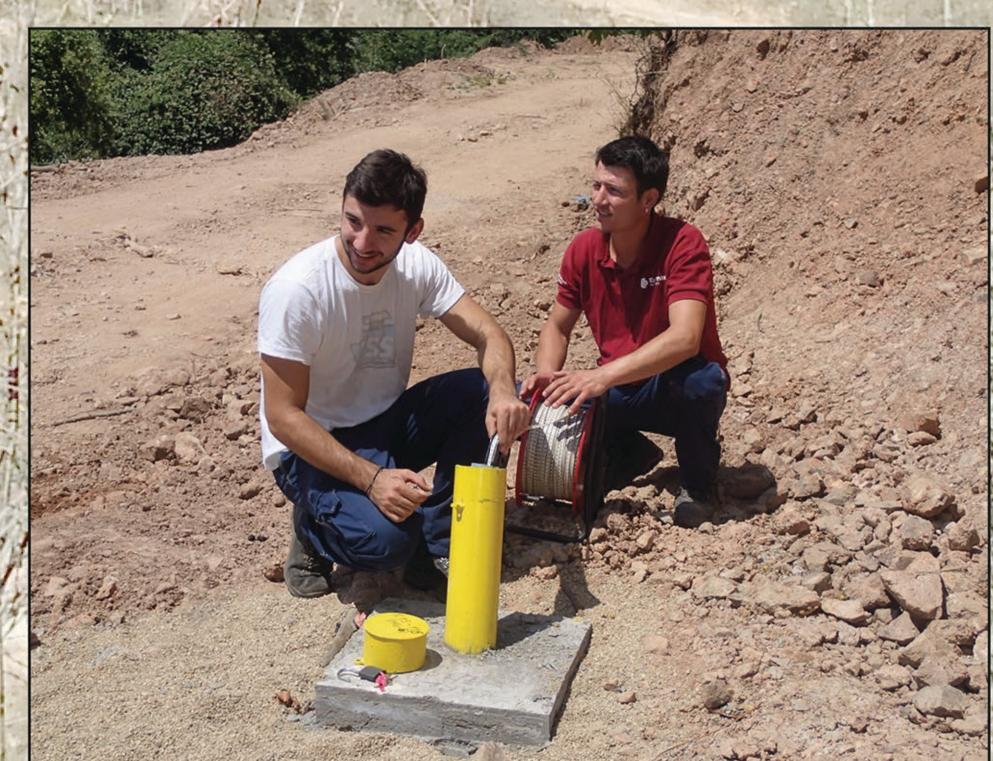
Measuring groundwater levels

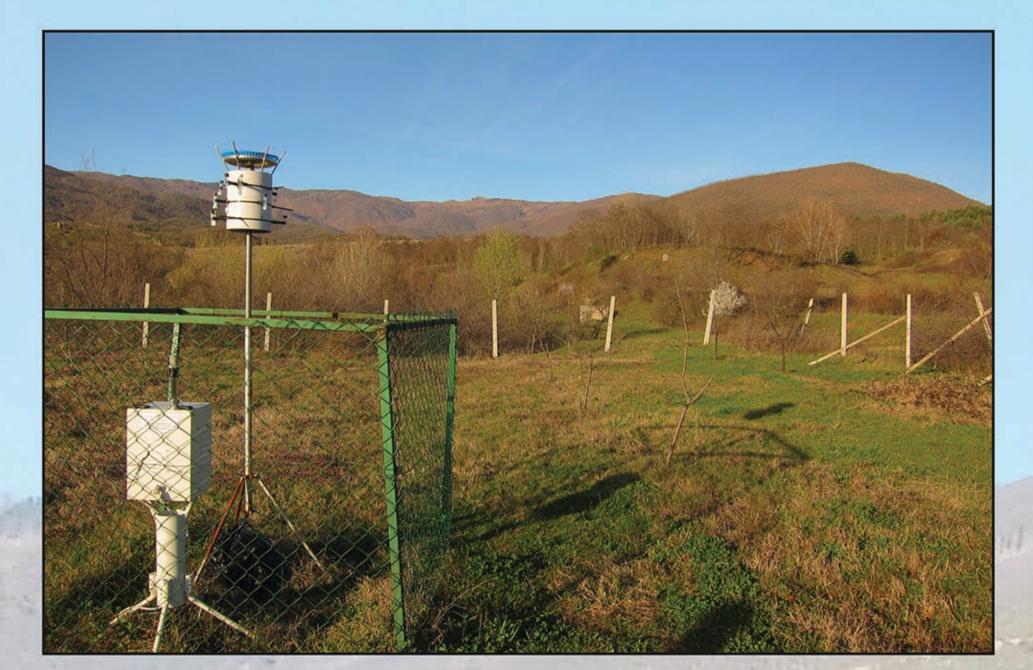
Osiris particulate monitor

Monitored fine particulates (PM10, PM2.5)

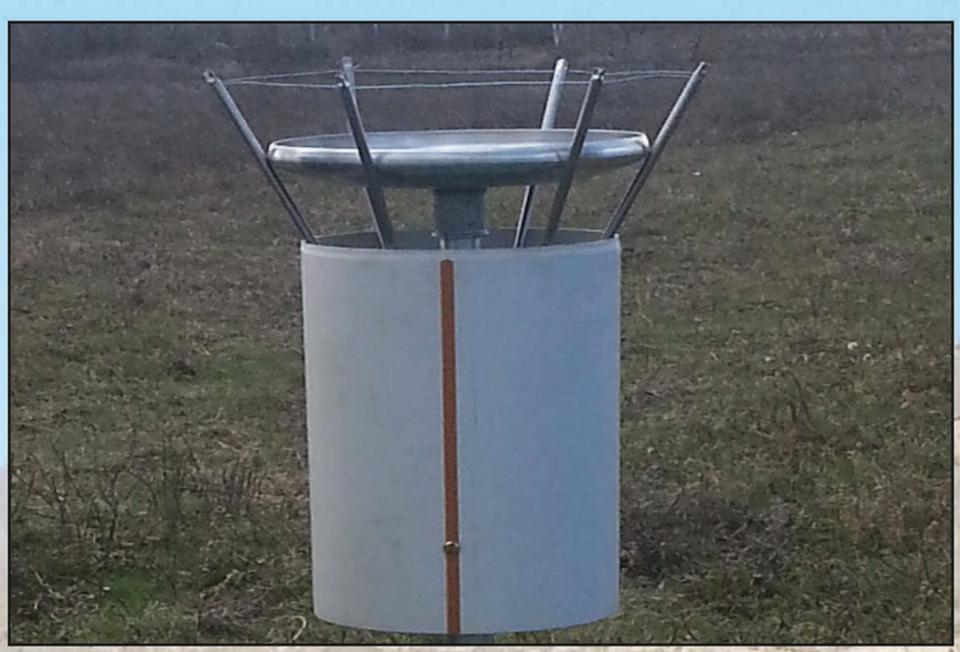
Frisbee guage Deposited dust

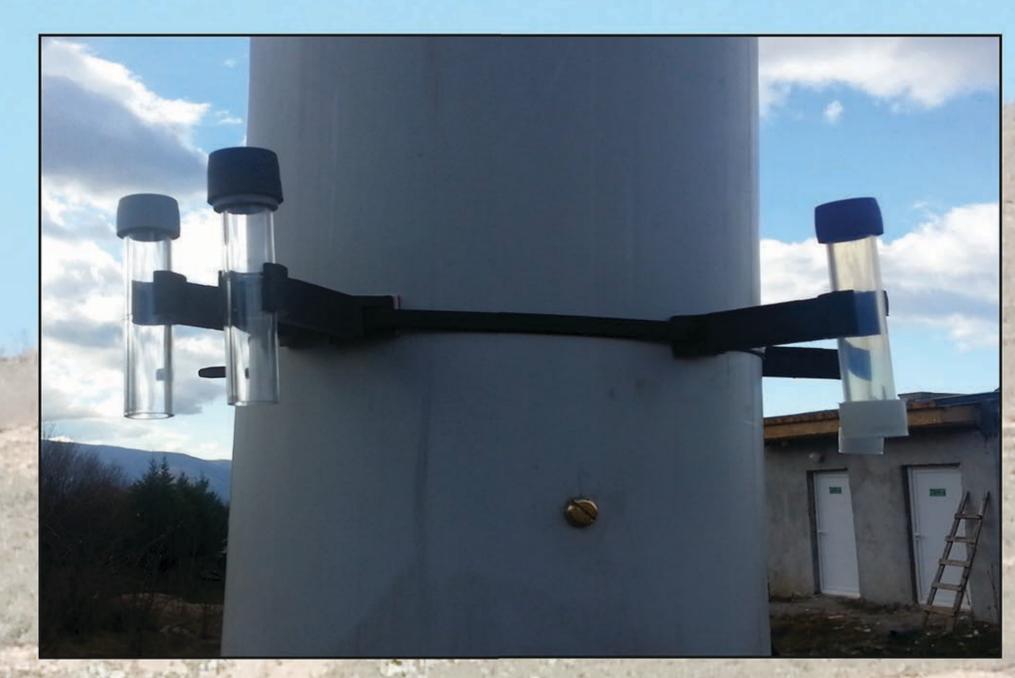
Diffusion tubes NO, NO<sub>2</sub>, SO<sub>2</sub> and O<sub>3</sub>
